# **AROUND THE LANDFILL SITES: A groundtruthing of solid waste management law across landfill sites in coastal areas of Uttara Kannada district, Karnataka**

**Centre for Policy Research (CPR)-Namati Environmental Justice Program**

**A groundtruthing of solid waste management law across landfill sites in coastal areas of Uttara Kannada district, Karnataka**

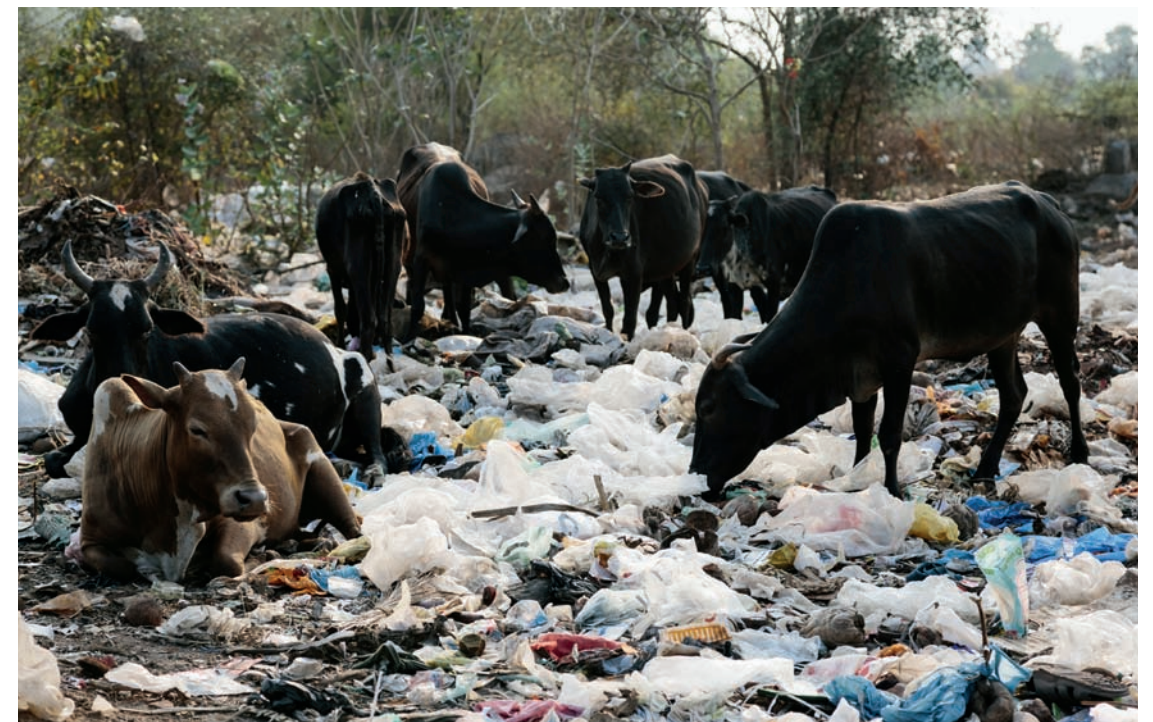
From April 2010 to February 2017, the Kumta Municipality claimed this forest area as its landfill site and continued dumping garbage there. The current site was 2 km away from the earlier landfill site which was purchased by the Municipality and approved by the KSPCB. There are three villages within a 1 km radius of this current dumping site-Siddanabhavi, Kagal Maneer and Harkade. Altogether, there are more than 900 people in these villages. Since the site is on top of the hill and the Municipality is dumping waste in an open area without any fencing or cover, most of the time light wastes are carried away by winds and end up reaching these villages. However, Schedule III, Rule 11 of the MSW Rules, 2000 states that landfill sites shall be fenced or hedged. Around 200 people from Siddanabhavi are directly affected every day because they are located very near to the landfill site. The most affected are daily wage labourers who are also unable to afford lawyers and incur the expenditures with filing court cases. Many of them cannot write and read and so will never be able to write to officials about their problem. Maybe that is why their problems have not come to the attention of the authorities. These people use community wells for their drinking water and domestic purposes. In the monsoon,

Cattle grazing on garbage- a daily sight at Muroor hill, March 2015

along with rainwater, the leachate flows downhill and reaches the water sources which they depend upon. In June 2015, some private hotel and lodge owners also dumped their waste just beside the landfill site. While meeting with the affected community that month, villagers shared that wastes from public toilets that wastes from the bus stand, public toilets, meat shops and market were being dumped in the pond near the landfill site and the stench spread all over Siddanabhavi village for weeks. These wastes when mixed with rainwater, further contributed to the contamination of their water sources.

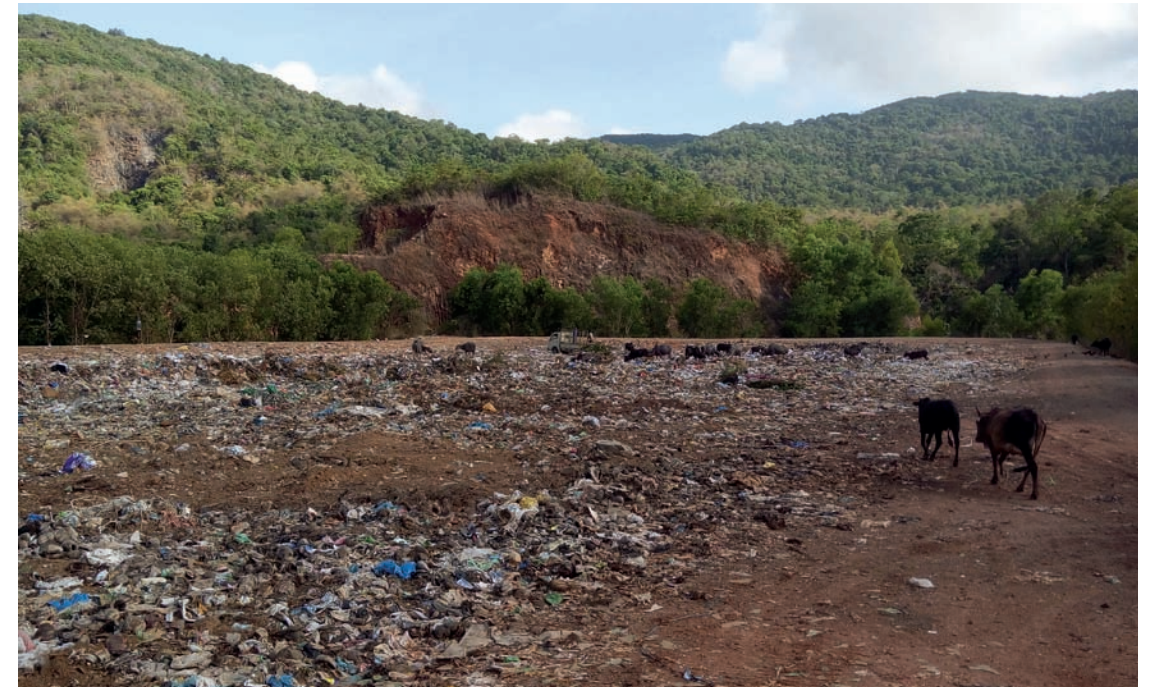
Non-compliance observed: Out of 24 clauses examined in Schedule III, MSW Rules, 2000, a total of 14 rules were complied with. However, 10 rules were not followed during the landfilling process. This led to several recorded conflicts between local people and the municipal authorities. When the site was visited, it was noted that facilities mentioned the MSW Rules, 2000 had been provided, such as a leachate collection tank, waste compactor, segregation unit and composting tank for wet waste. However, Nagaraj Naik who looked after the landfill site

Landfill site, Karwar Municipality

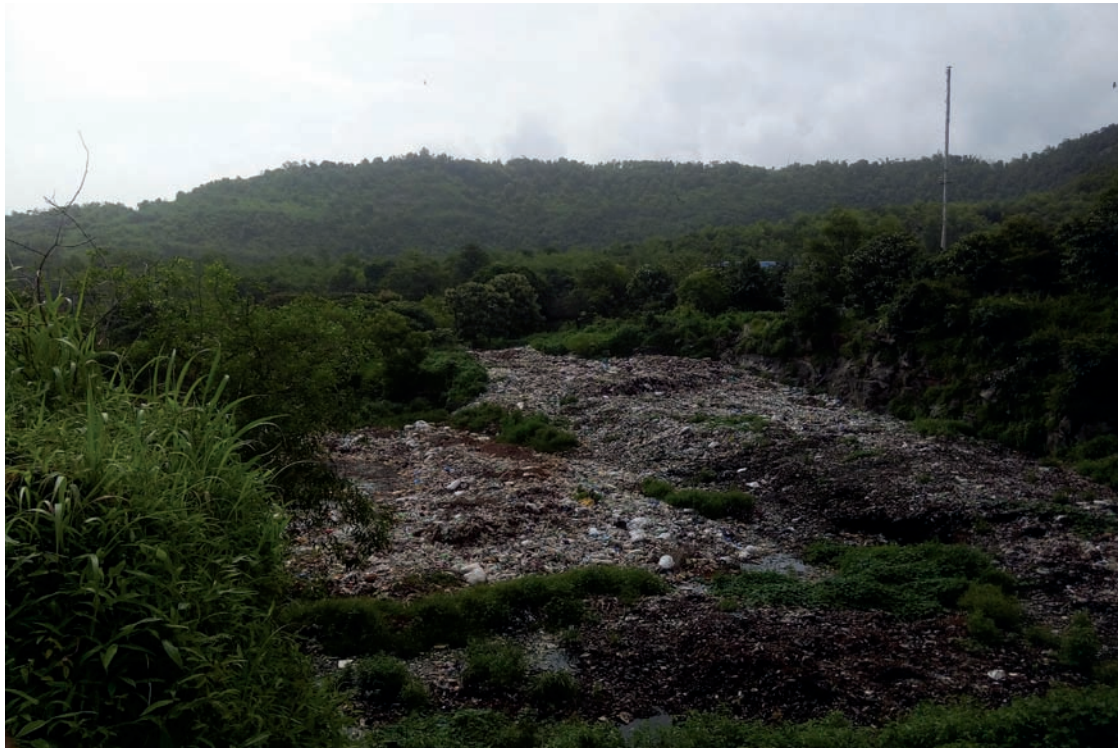
Bugaribail and Baleguliare the two villages affected by the landfill site. The landfill is located at a slightly higher altitude and a stream and rainwater from the hills flows through the landfill site during the monsoon.

Landfill site, Ankola Municipality

Impact of non-compliance: Villagers shared that nine wells had been contaminated by the leachate and as a result had not been used since the last four years. The primary school in the village was located just 100 m away from the site and unpleasant smells from the site reached the school all day. Villagers estimated that more than 100 families were affected by the landfill. Recently, the Karnataka Electricity Board also complained, saying that the landfill was next to the electricity grid and the burning of garbage there increased the danger of possible fires<sup>6</sup>.

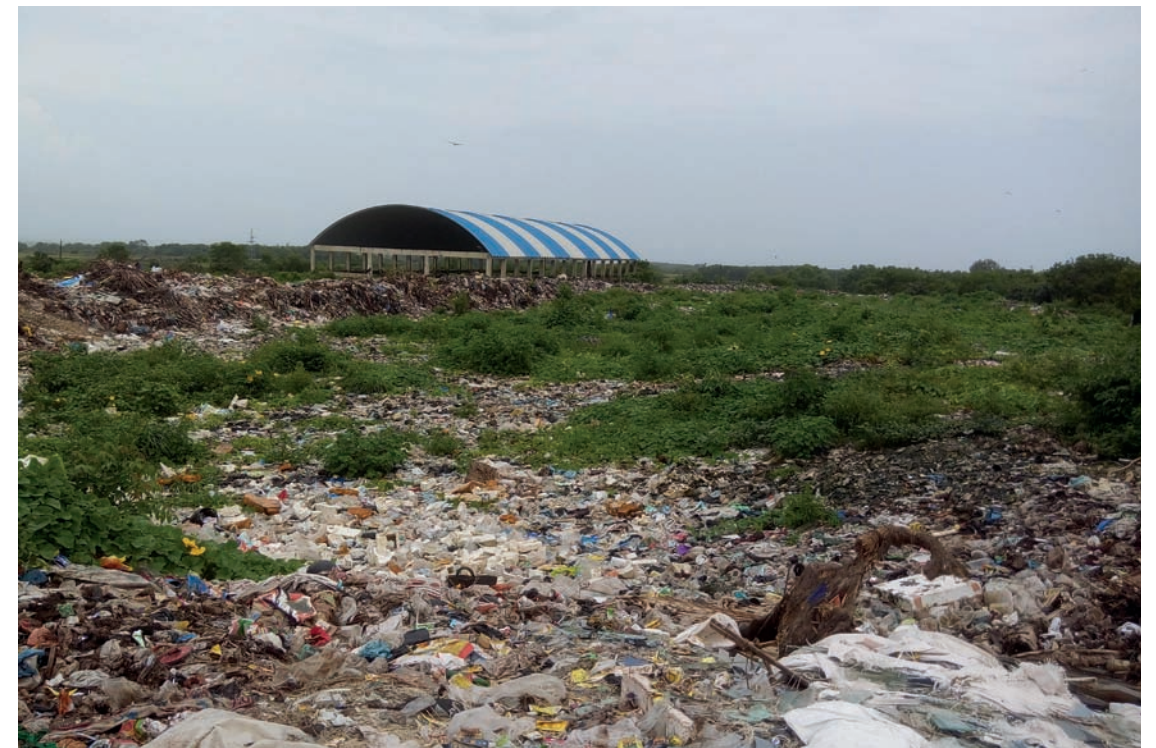
During the field visit, it was noticed that the landfill was not covered with a layer of soil as mandated by the MSW Rules, 2000 and solid waste was dumped in open places. It was also observed that segregation between dry and wet waste was not taking place and as a result no recycling of the same was noticed.

Landfill site, Honnavar Municipality

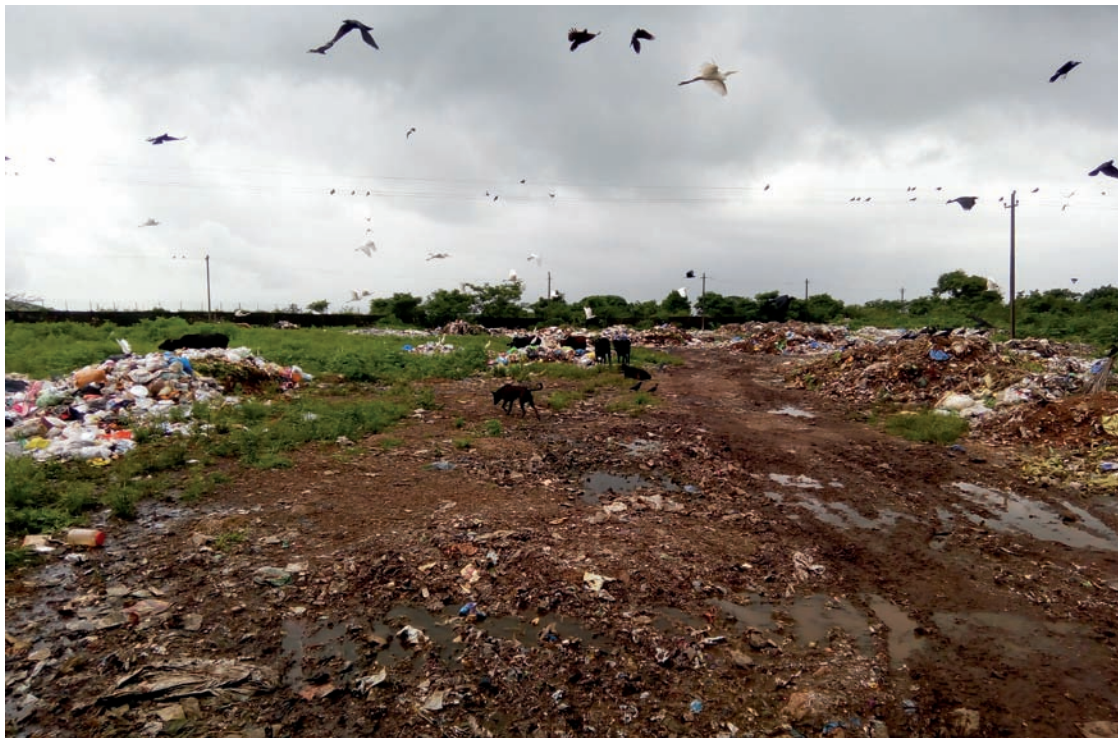
Non-compliance observed: While visiting the landfill site, it was observed that solid wastes were dumped openly and without any soil cover. This led to the wastes being dispersed to the nearby forest and farmlands. Another thing noticed was that the leachate was collected in a large pond and was released out of the unit by means of a pipeline. This leachate ended up being mixed with water from a stream beside the hill.

Landfill site, Bhatkal Municipality

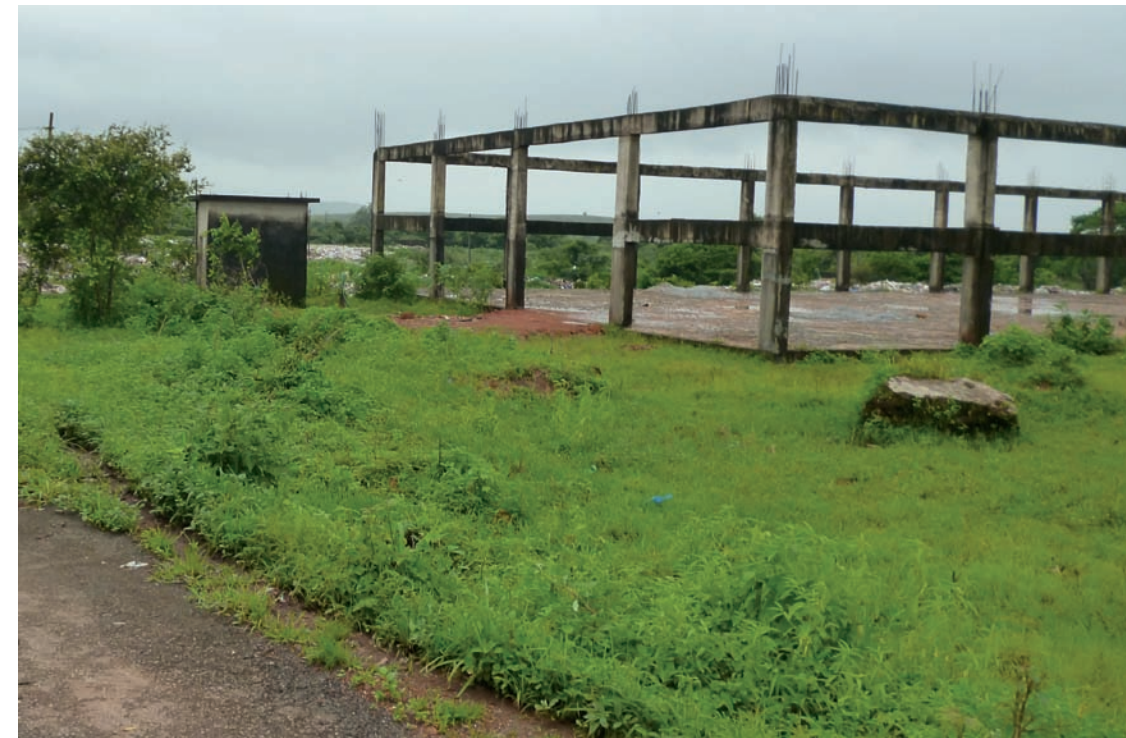
Of all the landfill sites, only those in Kumta and Karwar had taken clearance from the SEIAA. Other municipalities had not taken clearance from the SEIAA, but had sought the Consent to Establish from the Regional Office of the SPCB. In the September 24, 2016 reply to an RTI application filed with the Bhatkal Municipality, it was stated that though clearance from

Bhatkal waste processing unit under construction

the SEIAA had not been taken, the Municipality was operating the landfill site and the waste processing unit was under construction.

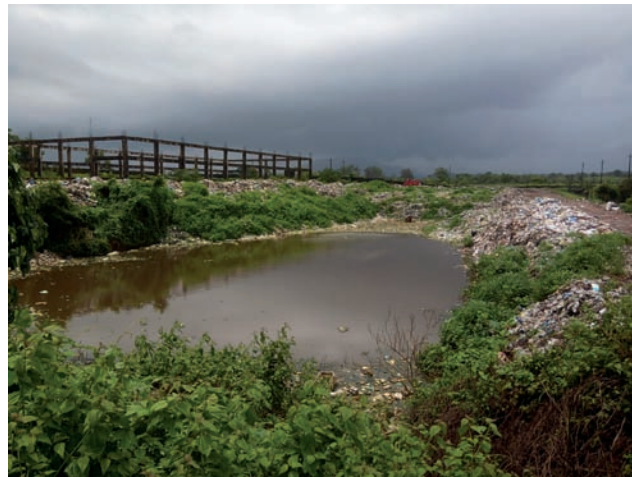
Leachate storage at the Bhatkal landfill site

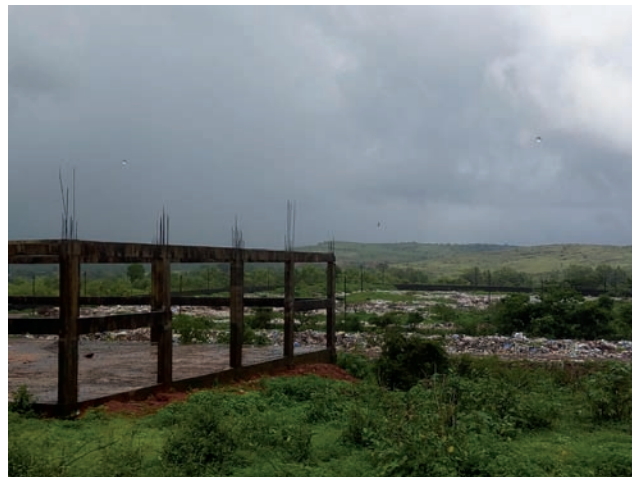
Waste processing unit under construction at the Bhatkal landfill site

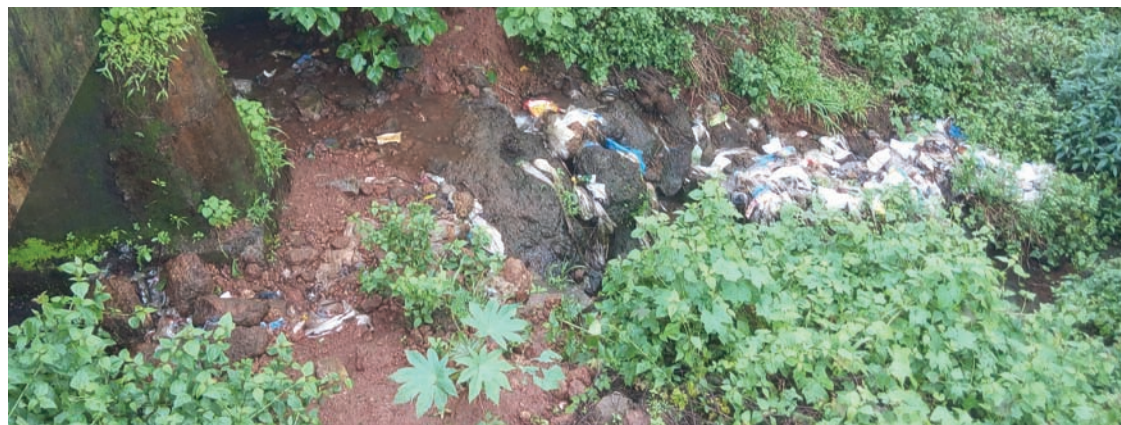
The Bhatkal landfill site was located slightly away from a habitation cluster, but near forest area and water sources of the village. In the absence of proper fencing around the site, both wild animals and cattle entered the area. There were farmlands beside the landfill site and the leachate collected from the site was directly released into the stream without any treatment. When this water was used for irrigation, it caused damage to farmers' agricultural lands. In view of this, the farmers approached the Bhatkal Municipality

Leachate released directly into the stream at the Bhatkal landfill site

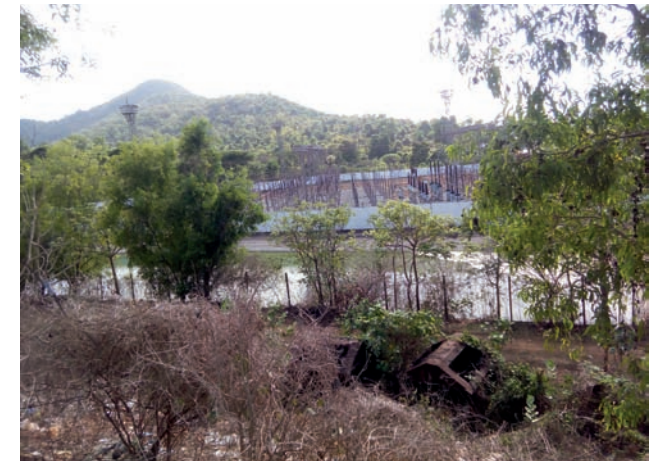
This is an important rule to avoid developmental activities near the waste disposal site. However, none of the municipalities have complied with this condition. For example, in Karwar, near the landfill site there are several industries located which caused disputes between the Municipality and the public. People who worked and lived near the landfill site protested against the Municipality, saying that the landfilling was done at an elevation higher than their drinking water sources, leading to leachate from the landfill flowing down into these sources. Only Karwar Municipality constructed a leachate collection tank to treat the leachate as per the law.

Leachate storage tank at the Karwar landfill site

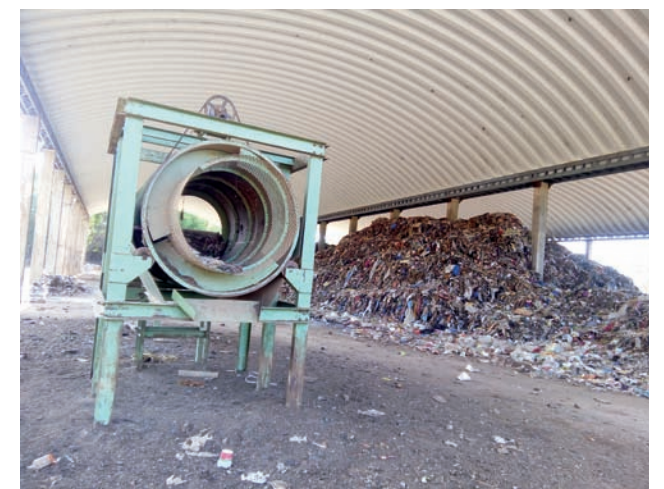
Waste compactor installed at the Karwar landfill site

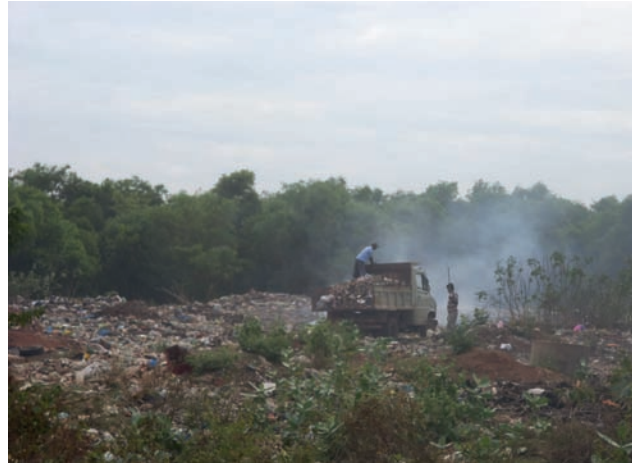
The CPR-Namati Program started working in Kumta in 2014. The landfill site here had been in under dispute for many years and because of violations of the law by the Municipality, villagers in the surrounding areas were suffering. One of the main problems for the Siddanabhavi villagers nearby was the dispersal of light waste into their village. The waste was not covered as per the law after the landfilling. These wastes entered their water sources and farmland which caused damaged to their daily life. Further,

Open dumping at the Kumta municipal landfill site

in the monsoon, these uncovered wastes mixed with rainwater and contaminated drinking water sources. In view of this, a training programme for the Siddanabhavi villagers about the MSW Rules, 2000 was conducted, along with a meeting with affected people and government officials. As result of this meeting, the Forest Department cleared the waste dumped by the private party on Muroor hill. It also placed a notice board at the site, stating that the area was forest land and dumping of unauthorised wastes was prohibited, and if found out was punishable. It even started patrolling the area to prevent the dumping.

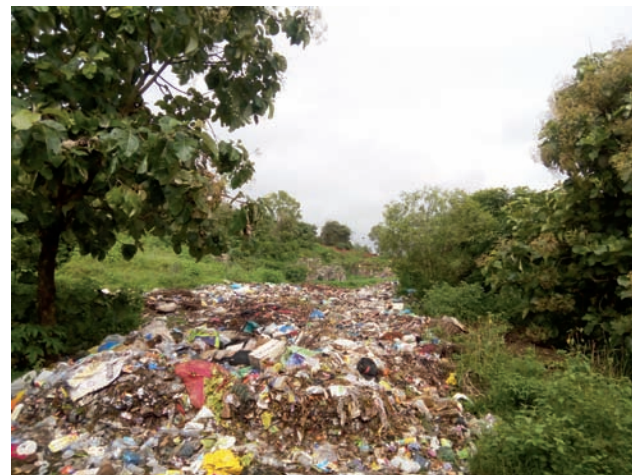
At the Ankola landfill too, wastes were not covered after the landfilling. In this regard, villagers had filed complaints with the Municipality several times. Unlike the Kumta landfill site though, the Ankola site was located very close to human habitations and uncovered wastes entered the houses and drinking water well of the villagers. Villagers had also witnessed the death of several cattle who consumed plastic wastes while grazing on the forest land.

Open landfilling at the Ankola site

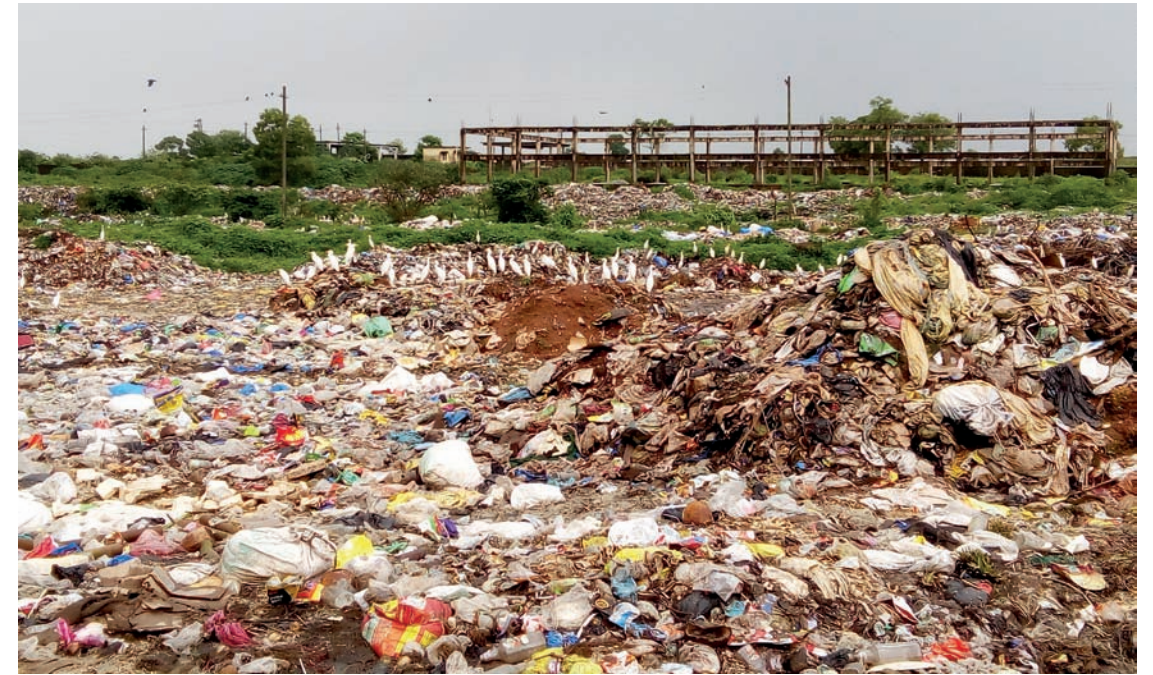
Wastes were not covered after their disposal at the Bhatkal landfill as well.

These wastes were available to cattle for grazing and birds for feeding. Due to this open dumping of garbage, street dogs frequented the villages looking for meat and other wastes. Also, the villages of Kasalagadde and Belalkanda, including the school in the latter, had to bear unpleasant odour throughout the year."

Birds feeding on uncovered wastes at the Bhatkal landfill site

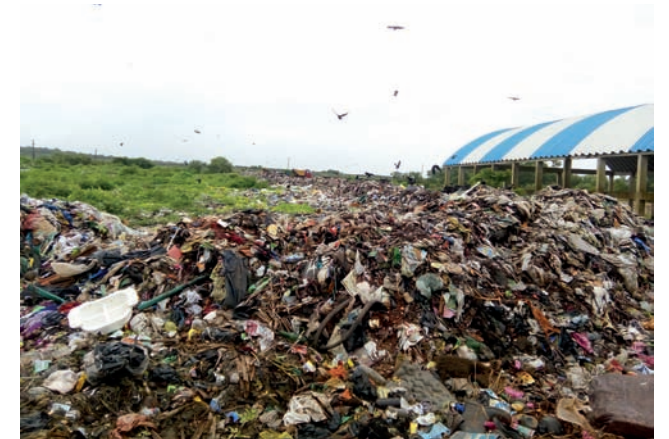
As both Honnavar and Karwar have landfills located slightly away from human habitations, no complaints had been registered so far even though wastes here were not covered after each day of landfilling.

Open landfilling at the Honnavar site

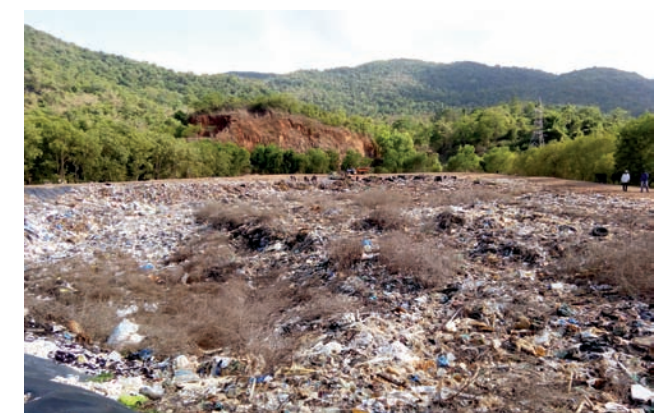
Violations of this rule in the landfill sites had contaminated the drinking water sources and agricultural lands on several occasions. During the

Landfilling site, Karwar

monsoon, drainage from the landfill sites mixed with rainwater and reached villages, agricultural lands and various water bodies such as streams, ponds and wells. In the villages of Kasalagadde and Belalkanda near the Bhatkal landfill site, the leachate during the monsoon contaminated the agricultural land and farmers' irrigation sources.

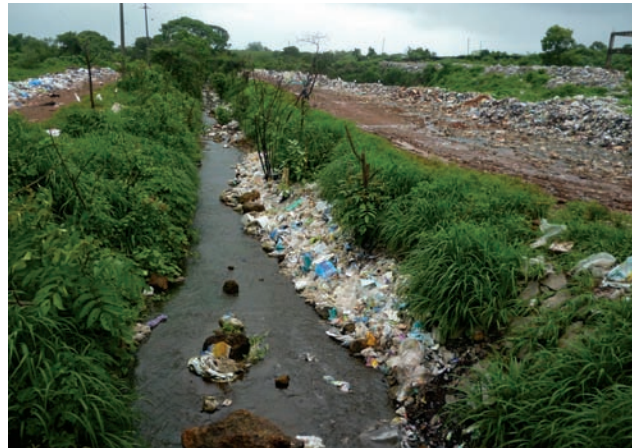
Due to the violation of this rule at the other three landfill sites, nearby villagers have experienced problems related to health and livelihood. At Bhatkal it was observed that landfill waste was never subjected to a final cover or any other protection measures. As a result of this, stray animals were affected. Also, the openly dumped garbage dispersed to nearby agricultural fields during strong winds. So far, villagers had not filed any complaints regarding these problems, but for more serious ones such as the intrusion of leachate into agricultural fields.

Landfill with no proper compaction and grading to prevent infiltration during monsoon in Bhatkal

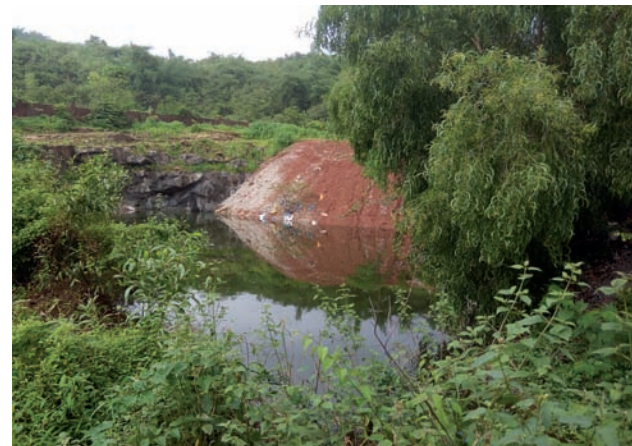
Monsoon rainwater and landfill leachate accumulated at the Ankola landfill site

In Ankola too violation of this rule was noticed, but according to the villagers having the landfill site in between villages was the only violation of law. The violation of this rule did not matter to them and all they wanted was for the entire unit to be relocated away from the villages.

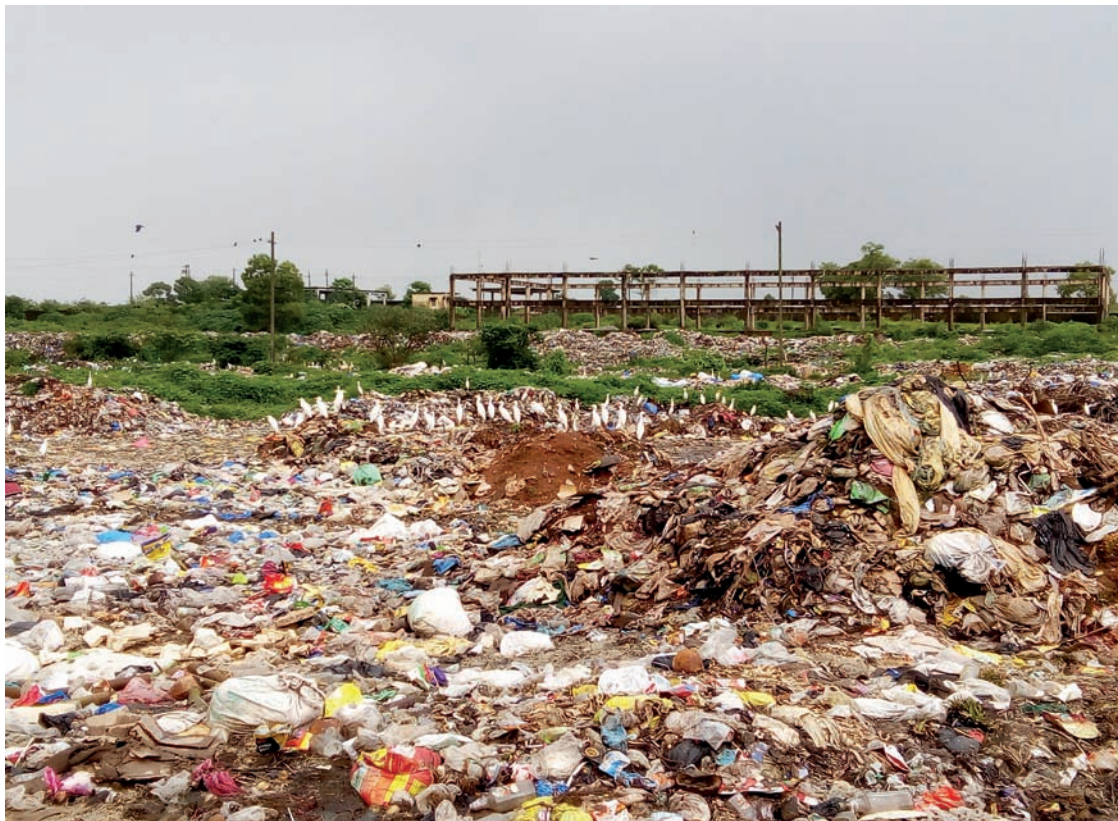
Bhatkal landfill site without final cover

- i) Addressing the violations at existing landfill sites:** Existing landfill sites in Ankola and Bhatkal which are in violation of the EIA Notification, 2006 and the MSW Rules, 2000 should be shut down. Fresh clearance procedures can be started to establish new landfill sites.
